TEPCO Fukushima Daini Nuclear Power Station
Research on the status of response to the Tohoku-Pacific Ocean
Earthquake and Tsunami and Lessons learned therefrom
(Proposals)

October 2012

Japan Nuclear Safety Institute

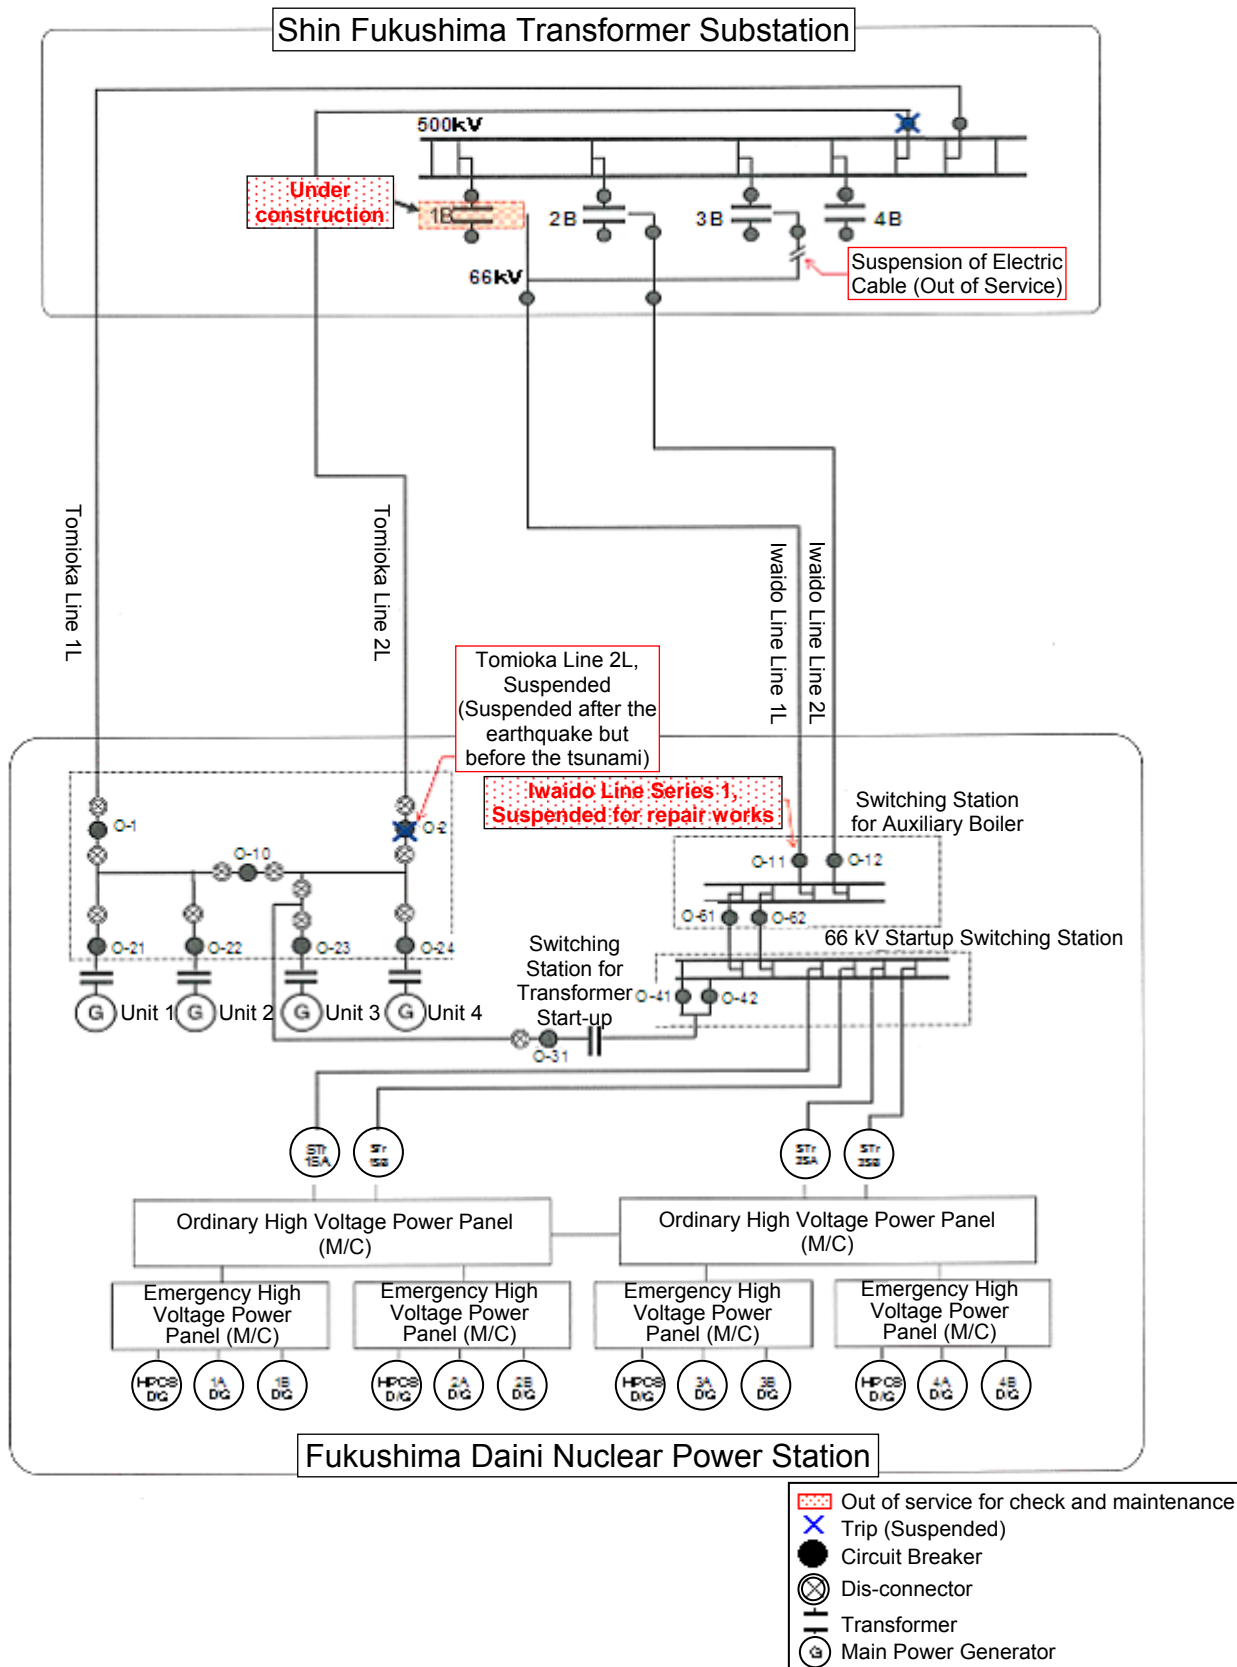
Fig 3.4.1-1 Fukushima Daini Outline Diagram of External Power Supply

After the earthquake, Tomioka 2L went out of service at around 2:48 pm on March 11 due to damage to the breakers at the Shin Fukushima substation. After the earthquake, patrol inspection of facilities found damage at the arrester of Iwaido 2L, so after confirming that Tomioka 1L was continuously receiving all the power necessary for the station, Iwaido 2L was put out of service for restoration works in order to prevent the damage from spreading further.

As a result, after the earthquake, the external power supply was only available from a single line for the time being. However, Iwaido 2L resumed service at 1:38 pm on the next day, March 12, and Iwaido 1L was also revived at 5:15 am on March 13 after temporary restoration, giving the receiving configuration three lines.

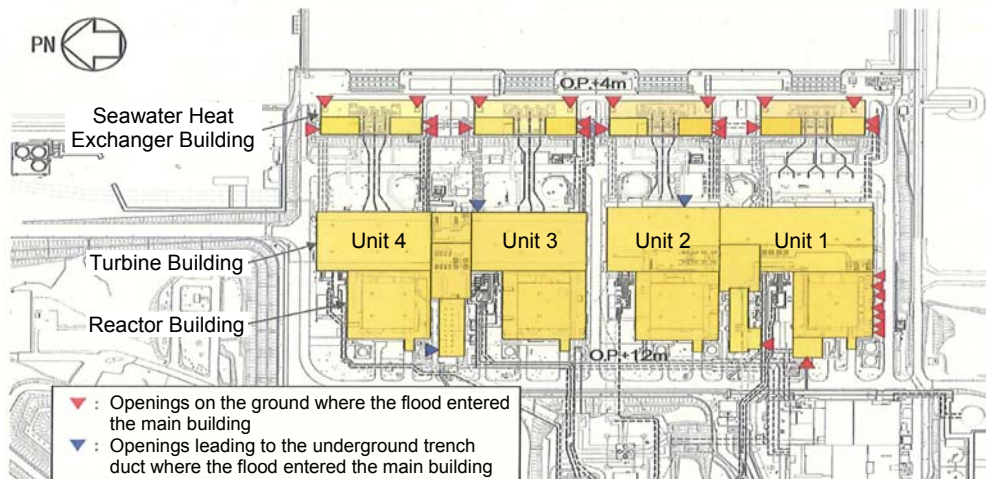
Fig 3.4.2-1 Openings of flood entrance into the main building

Intensive tsunami run up entered the Unit 1 building through the openings at ground level located on the south side of the reactor building (air intake louver for the emergency D/G, equipment hatch on the ground level) which flooded the reactor building (annex building) and caused the loss of function of all three units of emergency D/G, emergency power supply (for the C system and high pressure core spray system).

The depth of run up around Unit 2 through Unit 4 was not significant, and thus flooding into the reactor buildings or turbine buildings through the openings at ground level was not detected. However, flooding was confirmed in the basement of the reactor building of Unit 3 (Annex) and the basements of turbine buildings Unit 1 through Unit 3. It is thought that tsunami inundation entered the buildings through the cables and pipes leading to the underground trenches and ducts.
