**Responses to the Tohoku–Pacific Ocean Earthquake and
Tsunami at the Onagawa Nuclear Power Station and
Tokai No.2 Power Station (report)**

August 2013

Japan Nuclear Safety Institute

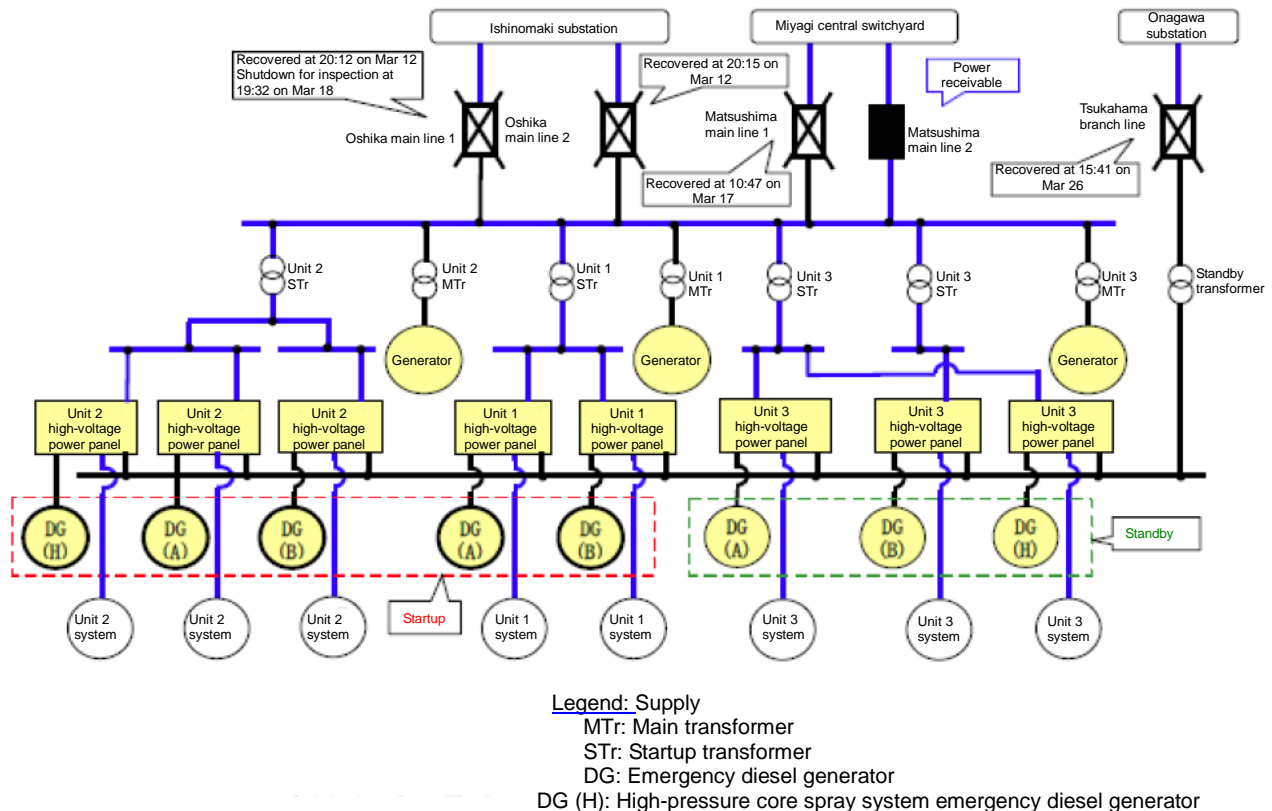
Figure 4.2.1 Off-site power source schematic diagram

Five circuits (Oshika main line 1, 2 (275 kV), Matsushima main line 1, 2 (275 kV), and Tsukahama branch line (66 kV)) are connected to Onagawa as off-site power sources. Shortly after the earthquake, only Matsushima main line 2 with one circuit was available due to operation of the system protection circuits in association with the transmission line accident that occurred in the area managed by Tohoku-Electric Power Co., Inc. Then Oshika main line 1 was recovered at 20:12 on March 12, Oshika main line 2 at 20:15 on the same day, Matsushima main line 1 at 10:47 on March 17 and Tsukahama branch line at 15:41 on March 26.

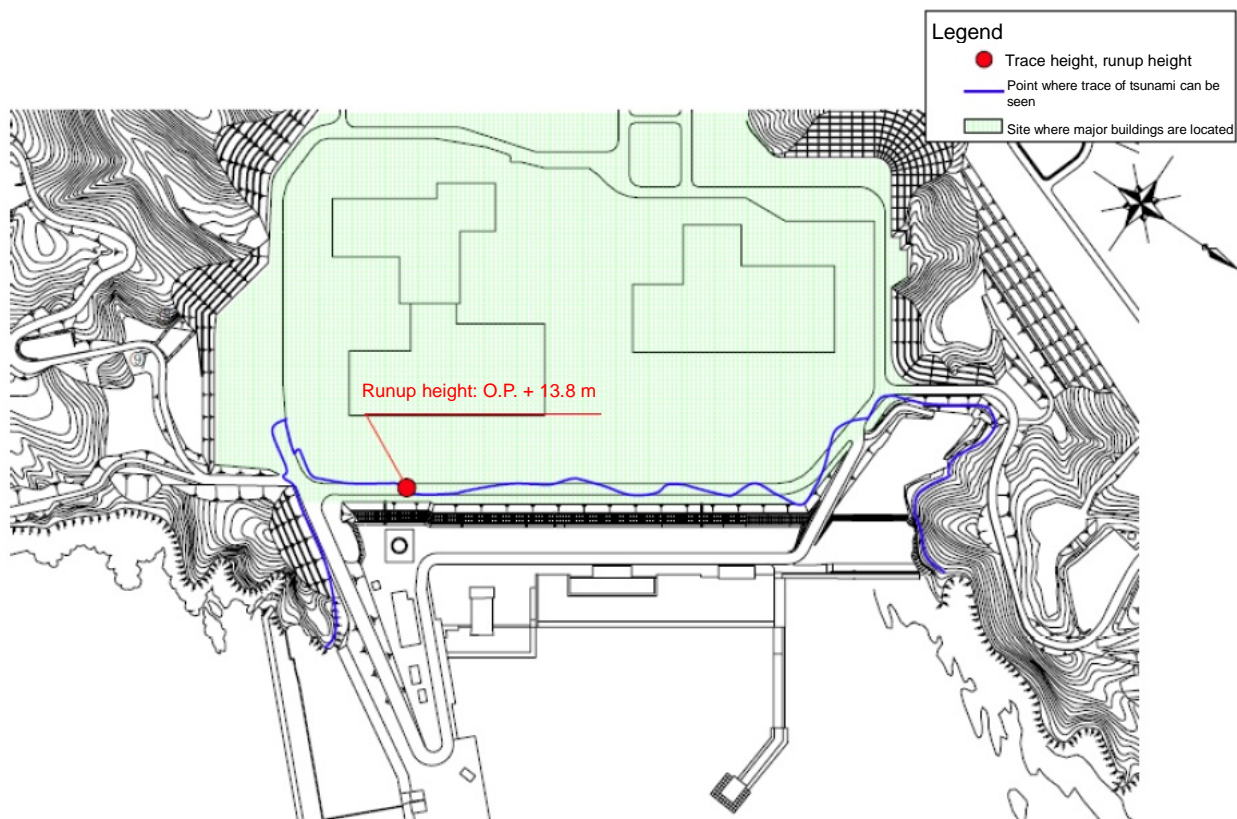
Figure 4.3-1 Trace survey result

The tsunami height observed by the tide indicator after the earthquake was O.P. + approx. 13 m* at the maximum and it was confirmed that this height did not exceed the site elevation of Onagawa (O.P. + approx. 13.8 m*). Though a trace of inundation was partly seen in the seaside of the site due to runup, the tsunami did not reach the major buildings.

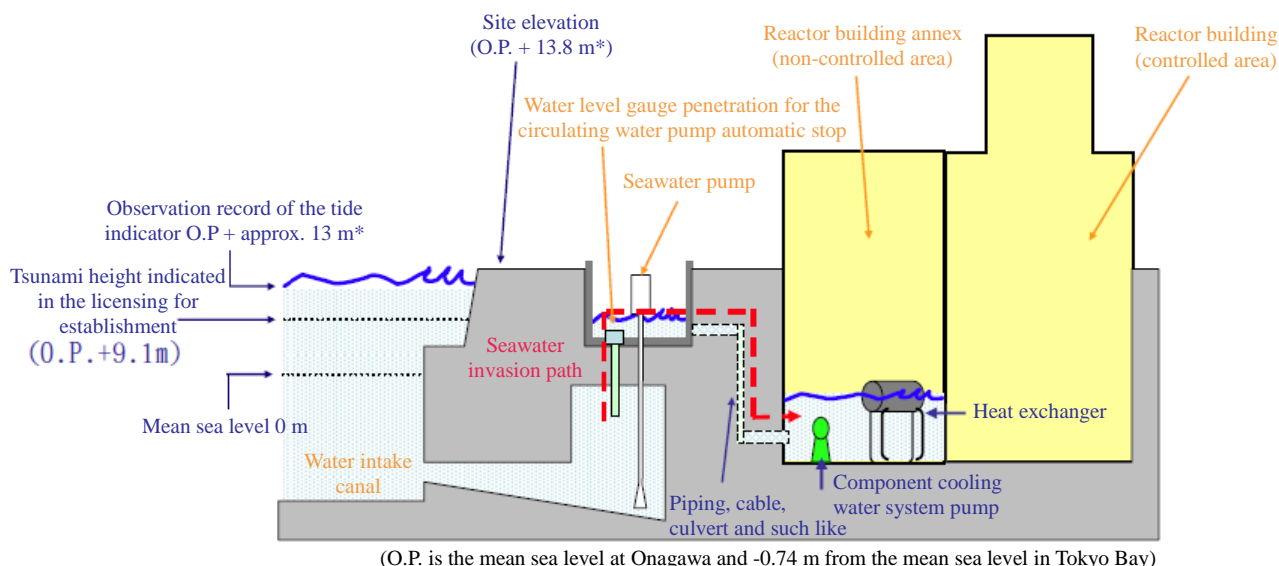
Figure 4.3-3 Inundation path to the reactor building closed-cooling-water system heat exchanger (B) room and such like at Onagawa Unit 2 (schematic view)

As seawater inundation was seen at the closed-cooling-water system heat exchanger room located at the reactor building 3rd basement of Unit 2 in the non-controlled area, the inundated reactor building closed-cooling-water system pump^{*2} (B) motors and high-pressure core spray component cooling water system pump^{*3} motors in the closed-cooling-water system heat exchanger room were found to

The cause of the seawater inundation might be that the upper lid of the water level gauge box located in the seawater pump room was lifted due to an increase in the water level caused by the tsunami. Then the seawater invaded through this gap, flowed into the basement trench via a cable tray and pipe penetration, and then entered the reactor building closed-cooling-water system heat exchanger room and other locations via pipe penetrations.

At a later date, the pertinent water level gauge was removed to make the opening waterproof. The plan was to relocate the pertinent water level gauge to a different area with a dust extractor. Though the same water level gauges were installed at Units 1 and 3, there was no damage to the reactor building closed-cooling-water system because the installation area was different (area with dust extractor).

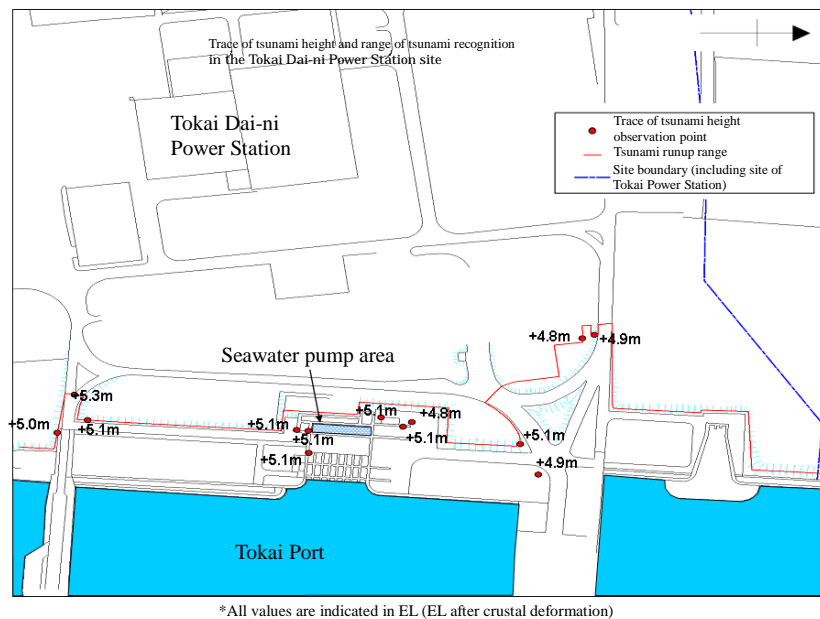
Figure 8.3-1 Inundation by tsunami at the Tokai No.2 Power Station

Affected by the tsunami, all normal pieces of equipment at the sea side lost their functions, including the sea water electrolytic equipment and water intake canal dust extractor. When the tsunami hit, an earth fault alarm for the power system was generated; however, the situation was not checked until after the next day, when the response was made, because plant stabilization was prioritized. Though only the emergency diesel generator seawater pump (2C) lost its function among important-to-safety equipment, it caused no problem for the plant's cold shutdown operations.
