April 2, 2018

Kyushu Electric Power Company Inc.

Genkai Nuclear Power Station Unit 3:

Checking status of the small steam leak from the air vent pipe of the deaerator

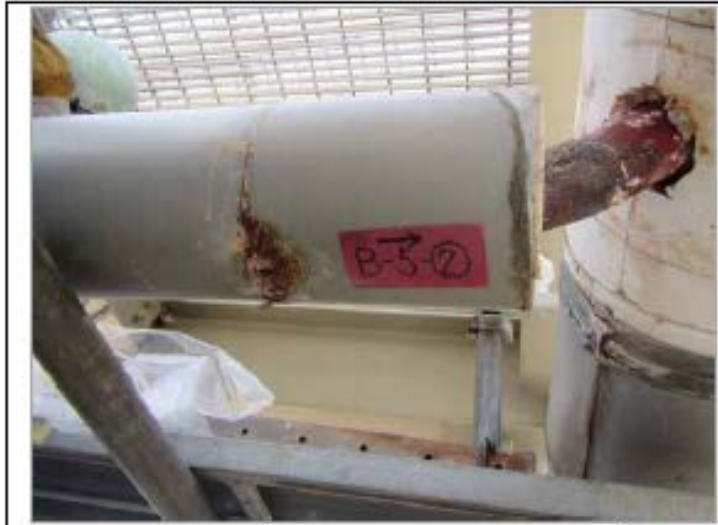
Photo ①

Significant rust was observed on a part of the lower surface of the exterior panel of the pipe.

- Near the Leak Point (5th Air Ventilation Pipe of the Deaerator 3B)

Replacement of the affected pipe, insulation material and exterior plate in which the penetrating hole was found will be conducted.

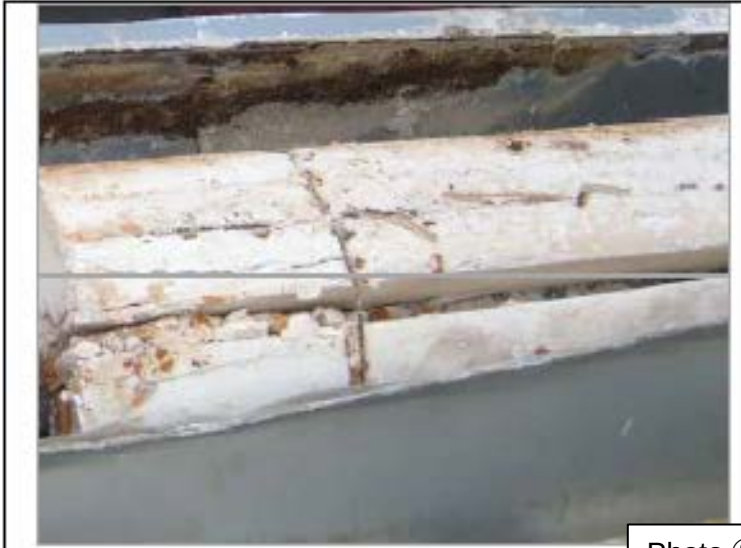
Photo ②

- Outside Observation Condition of Thermal Insulation Material (5th Air Ventilation Pipe of the Deaerator 3B)

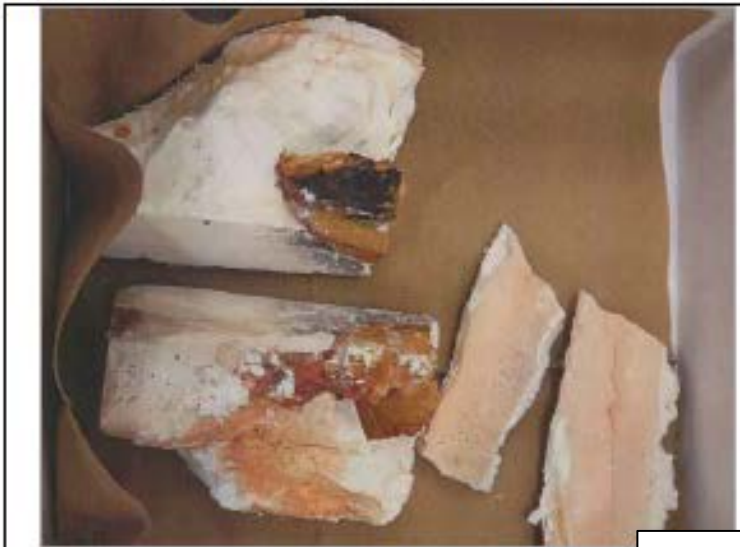
Photo ③

Adhered substances such as discoloration and rust were found in the heat insulation material, which contacts the pipe partly.

Confirming the situation of the exterior panel and pipe, it is considered that rainwater intruded from the gap of the exterior board, the heat insulation material absorbed water and became a wet state, causing the erosion of external parts, which progressed and became penetrating hole.

- Inside Observation Condition of Thermal Insulation Material (5th Air Ventilation Pipe of the Deaerator 3B)

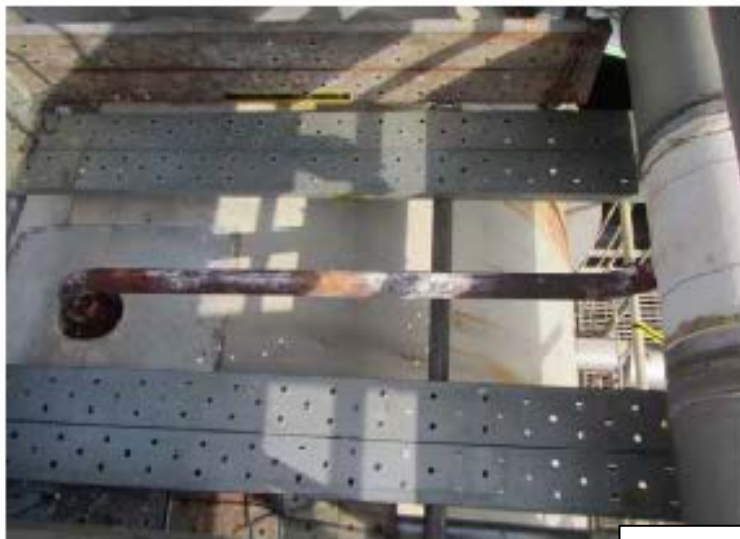
Photo ④

A clear indent was found in the horizontally running part of the affected pipe. The indent was on the upper side of the pipe and one penetrating hole (length approx. 13 mm × width approx. 6 mm) was found in it.

- o Leak Pipe(5th Air Ventilation Pipe of the Deaerator 3B)

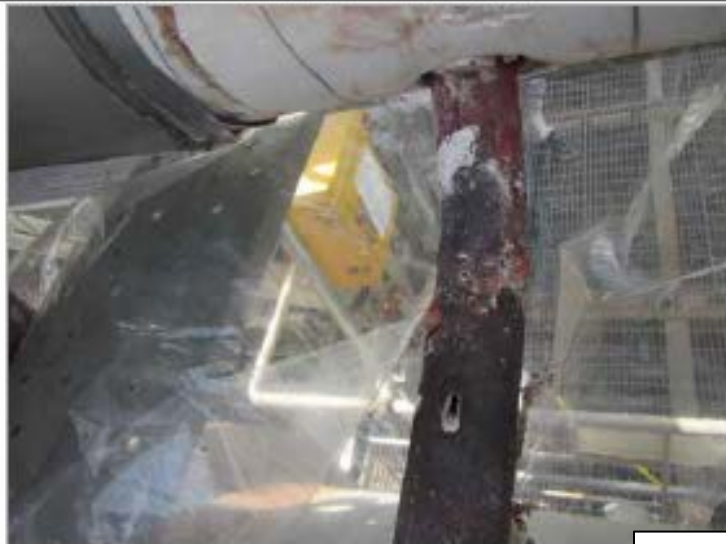
Photo ⑤

The pipe in the vicinity of the penetrating hole was indented in the direction

from the outside to the inside of the pipe.

- o Leak Point (5th Air Ventilation Pipe of the Deaerator 3B)

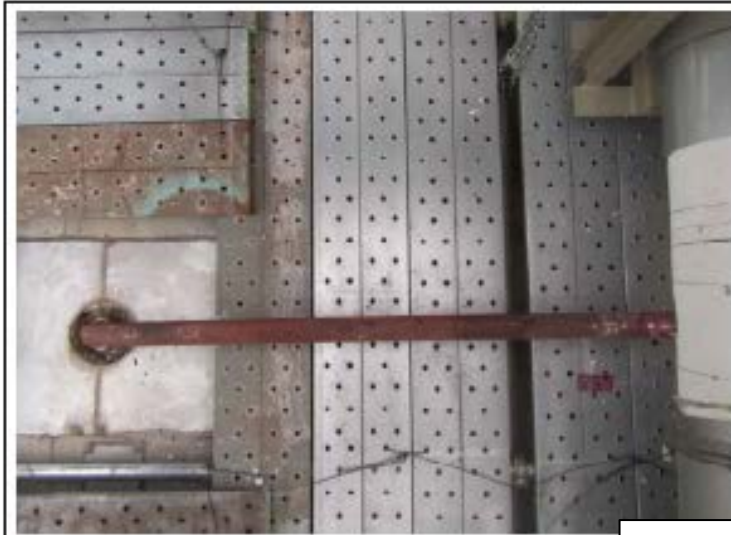
Photo ⑥

No clear indent was found in the air ventilation pipes other than the affected pipe.

※Photos of ⑥ and ⑦ were taken at 3rd Air Ventilation Pipe of 3A Deaerator for comparison with an undamaged pipe

- o Other Leak-Free Pipe (3rd Air Ventilation Pipe of the Deaerator 3A)

In addition, with respect to 15 air ventilation pipes other than the affected pipe, the heat insulation material and the exterior board will be replaced with new ones. At the same time, all the air ventilation pipes will be replaced as precaution.

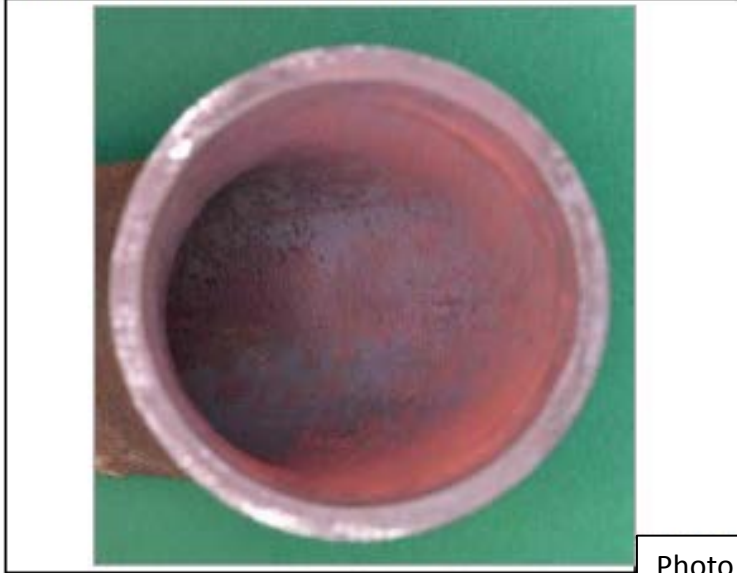
Photo ⑧

After detaching the affected pipe, a fiber scope was inserted inside and check of inner surface of the pipe was carried out. As a result, the penetrating hole was found on the upper side of the pipe running horizontally.

The inner check revealed there was no clear denting in the direction from the inside to the outside of the pipe.

- Inside Observation Condition of Leak Pipe  
(5th Air Ventilation Pipe of the Deaerator 3B)
