TEPCO Fukushima Daini Nuclear Power Station
Research on the status of response to the Tohoku-Pacific Ocean
Earthquake and Tsunami and Lessons learned therefrom
(Proposals)

October 2012

Japan Nuclear Safety Institute

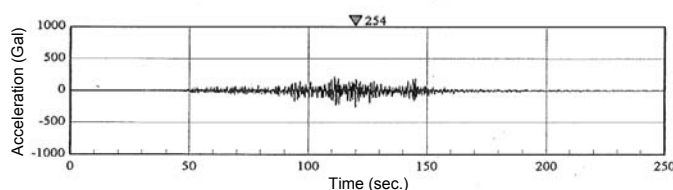
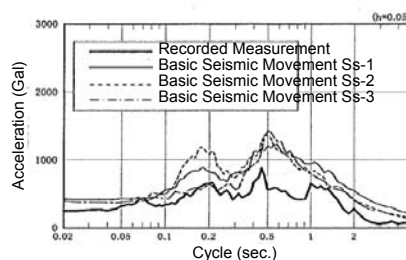
Fig. 3.2-1-1 Time History of Acceleration on the Ground Level of Reactor Building, Unit 1 (NS Direction)

The observed values of ground motion at the foundation of the reactor building (the lowest basement floor) of Fukushima Daini was below the maximum acceleration of design earthquake ground motion Ss (the maximum acceleration observed was 305 Gal on the B2 floor of the Unit 1 reactor building), and therefore this ground motion can be considered to be within the expected range of the seismic safety evaluation of the equipment.

Furthermore, using the recorded values of ground motion at the free field obtained during the earthquake, a soil structure model was identified for the strip analysis. As a result, ground motion of the strip analysis proved to be generally at the same level as actual observations, although the calculated values exceeded the design earthquake ground motion Ss in some of the periodic bands.
